Planning Appeal - Proof of Evidence

Appendix: BWHy1

APPEAL REF:APP/E2734/W/19/3236153

SITE AT: Land Comprising Field At 439236 449205 Harrogate Road Stockeld
North Yorkshire

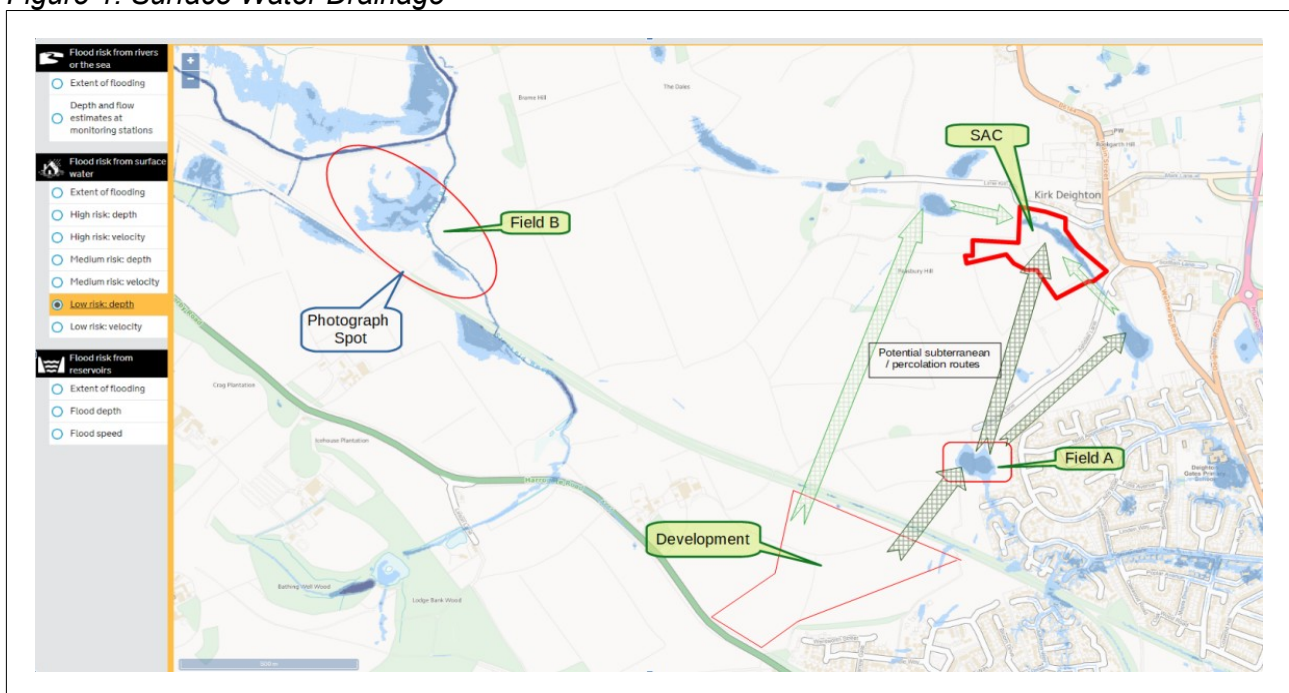
Figure 1: Surface Water Drainage

A1.2 In Paragraph 2.2 of the PoE document, I suggested that the principal drainage from the proposed site is in accordance with the schematic diagram (Figure 1) below. This diagram incorporates the “low-risk” surface water flooding ‘ponds’ depicted in the government flood warning maps ((<https://flood-warning-information.service.gov.uk/long-term-flood-risk/map>))

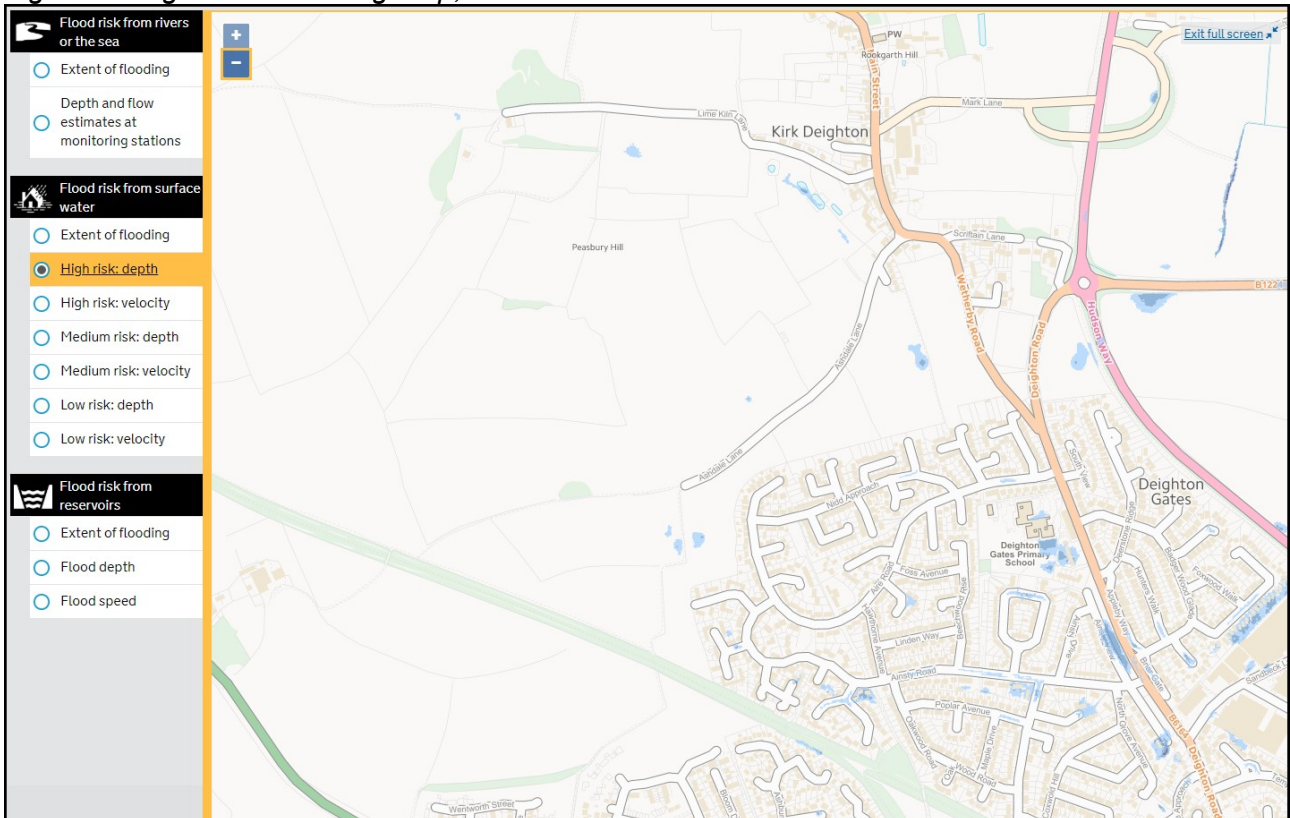
Figure 2: 'High-Risk' Flooding map, Field A & SAC

A2.3 I believe that the above observations are indicative of a high water table and a fairly rapid response to rainfall. Examination of the flood warning maps would appear to back-up these observation, the 'high-risk' ponds depicted in Figure 2 are indicative of fairly regular flooding of Field A and a considerable merging of the SAC ponds.

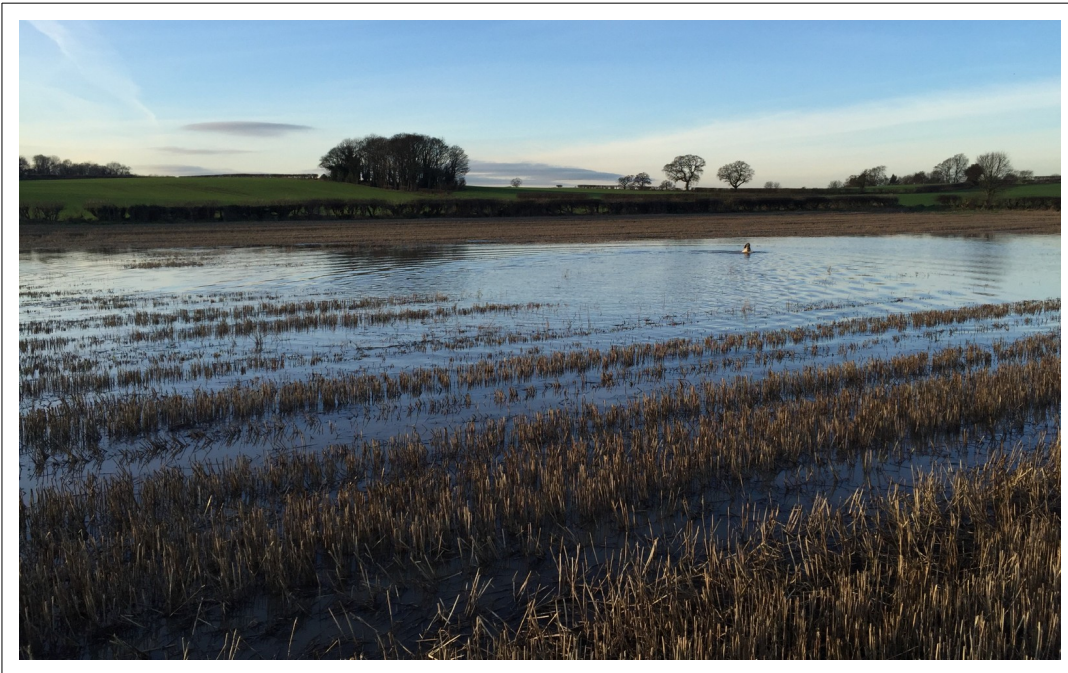
Figure 3: Field A on 27 Dec. 2015

A2.4 The photos below (Figures 3 & 4) show flooding on Field A in late 2015 / early 2016. These photos were taken following a considerable period of rain, according to Met Office figures for NE England approximately 60mm of rain fell in the previous 3 days. As might be expected, these correspond very closely with the predicted 'low' risk flood map in Figure 1.

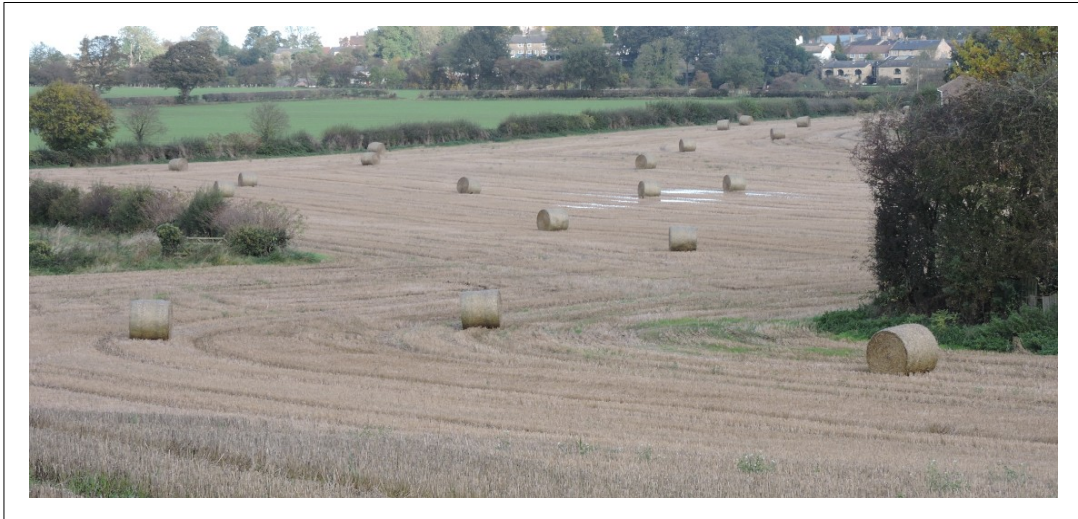
Figure 5: Field A on 27 Oct. 2019

A2.5 The photographs above (Figures 3 & 4) can be contrasted with Figure 5 below of the same field taken on 27 October 2019, again following a considerable period of heavy rainfall (29mm in previous 3 days). This shows minimal surface water, all of which had disappeared the following day.

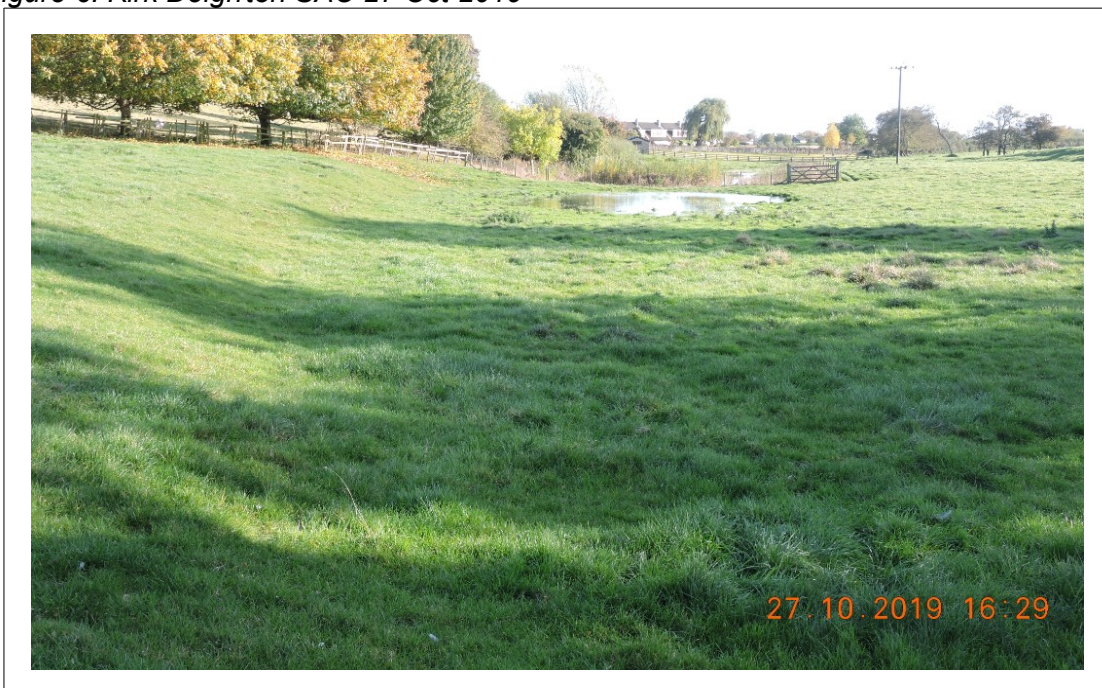
Figure 6: Kirk Deighton SAC 27 Oct 2019

A2.6 On the same day (27 October 2019) the following photograph (Figure 6) was taken of the ponds at the SAC, these show the water levels to be much in line with 'normal' levels as depicted in Ordnance Survey maps and show no evidence of 'flooding'.

A2.7 The position where the photograph (Figure 6) was taken was totally flooded prior to 2017 following periods of moderate/heavy rainfall. The water levels shown in Figure 6 do not correlate, as would be expected given the conditions that day, with the UK flood water map shown in Figure 1, or even the lower levels shown in Figure 2.

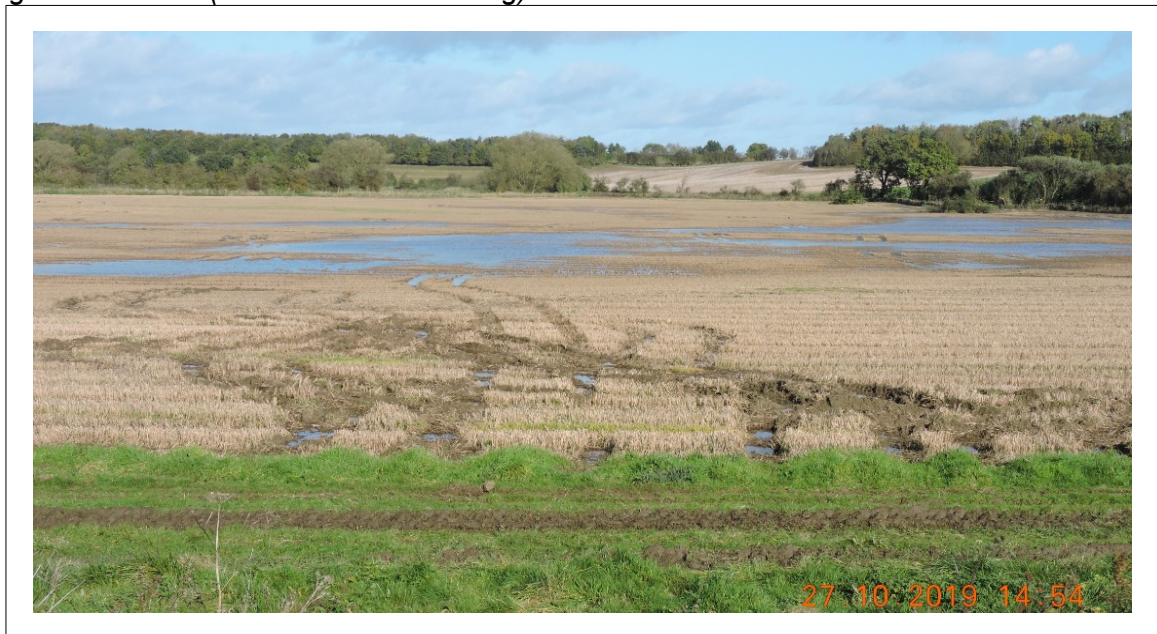
Figure 7: Field B (North Western flooding) 27 Oct 2019

A2.8 As a comparison with the minimal increased water levels shown in Figures 6 & 7, the following two photographs (Figures 7 & 8) were taken on the same day of 'Field B' (see Figure 1) from a point on Harland way approximately 1800m from the proposed site. The flooding here **correlates closely with the predicted "low" risk flood map in Figure 1.**
